The NASA Deferred Maintenance Parametric Estimating Guide Version 5

For NASA's
Facilities Engineering and Real Property
Division

September 15, 2005

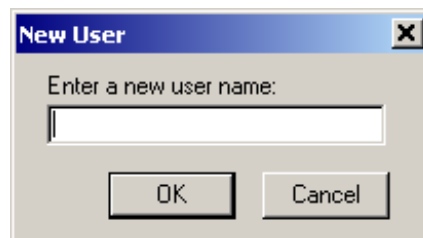
Figure 4: "New User" dialog

8. Next click the [**New...**] button to add a new user using the "New User" dialog, Figure 4. You will need to add one for each team's Palm PDA.

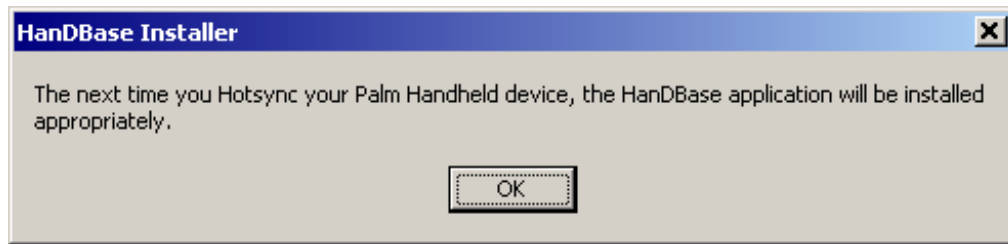
Figure 14: Install Dialog

9. The dialog shown in
10. Figure 14 will appear. Click [**OK**].

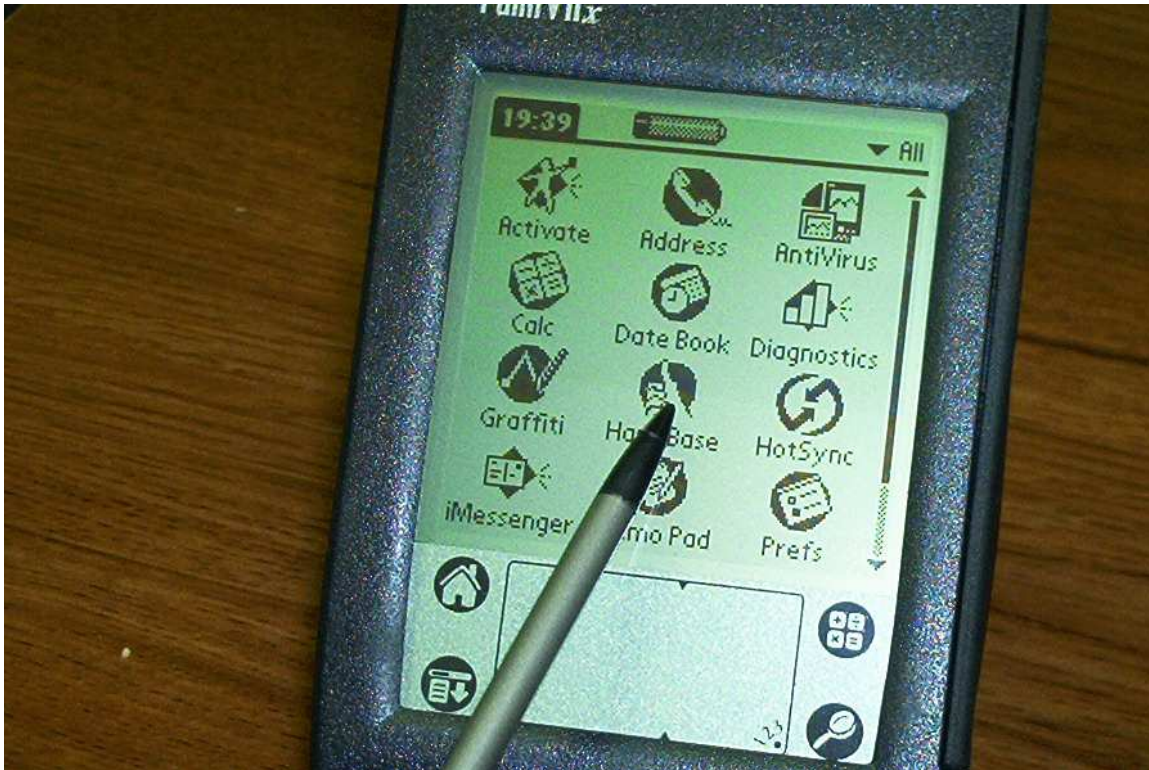
Figure 22: Select the HanDBase icon

1. Turn on the Palm PDA and select the HanDBase icon as shown in Figure 22.

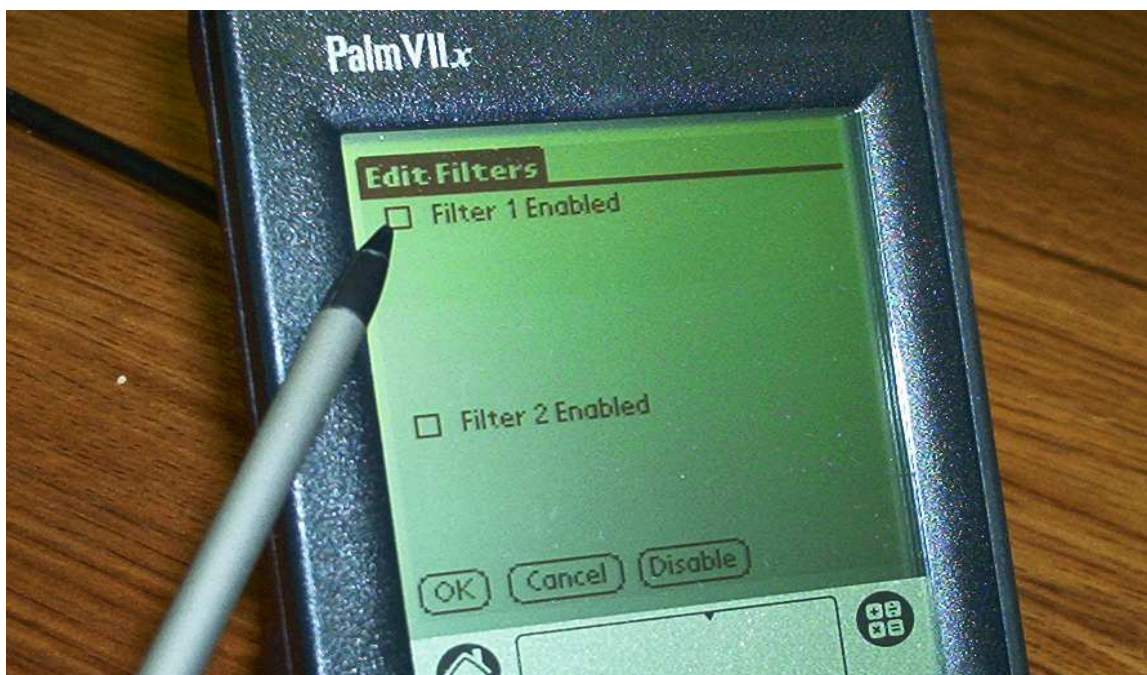
Figure 25: Edit Filters screen

6. An **Edit Filters** screen appears as shown in Figure 25. Tap on the checkbox for **Filter 1** as shown in the figure.

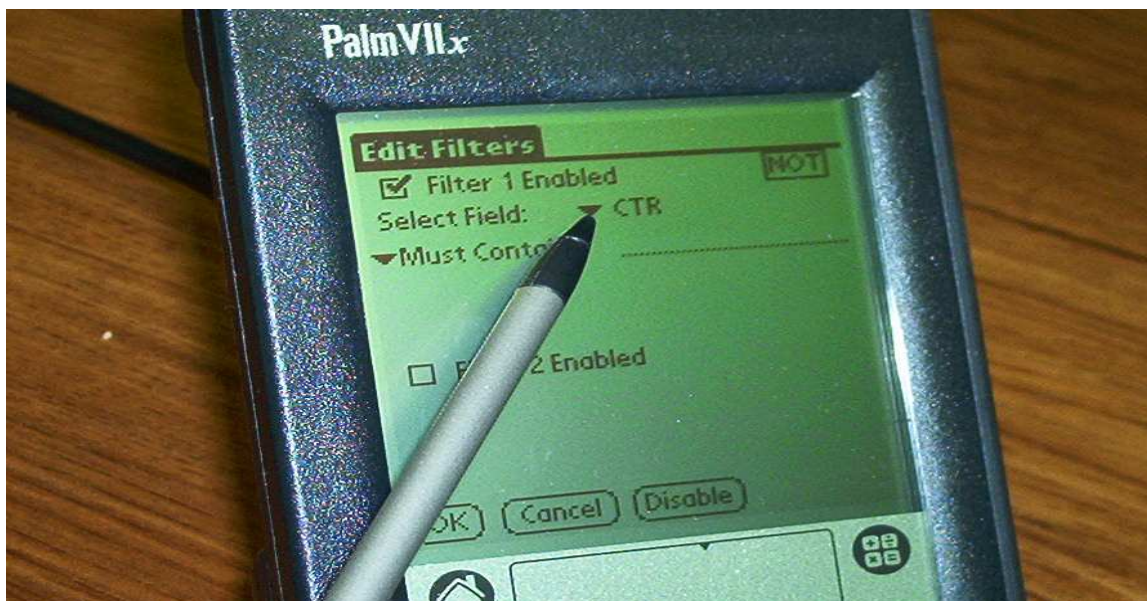
Figure 26: Tap on the drop down arrow to the left of CTR

7. Tapping on the checkbox for **Filter 1** enables the filter and the **Select Field:** drop down (defaulted to **CTR**) as shown in Figure 26. Tap on the drop down arrow to the left of **CTR**.

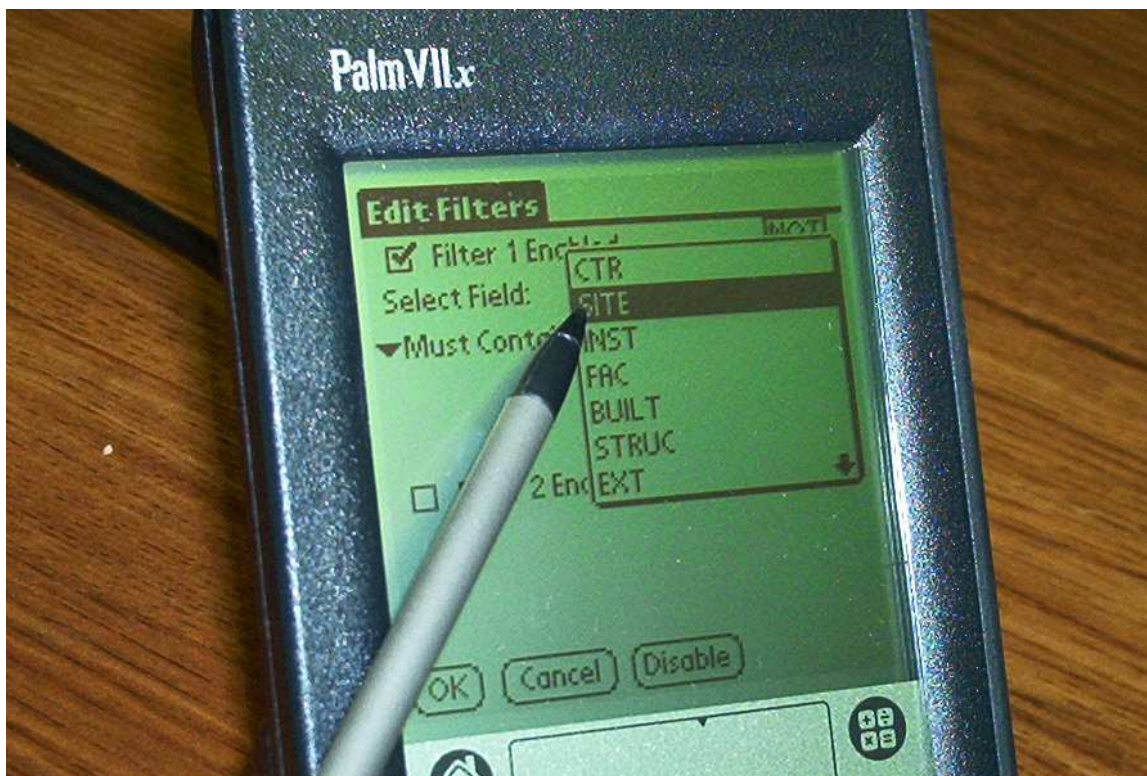
Figure 27: Select the SITE choice

8. Select the **SITE** choice from the resulting menu as shown in Figure 27. Next enable **Filter 2** by tapping its checkbox.

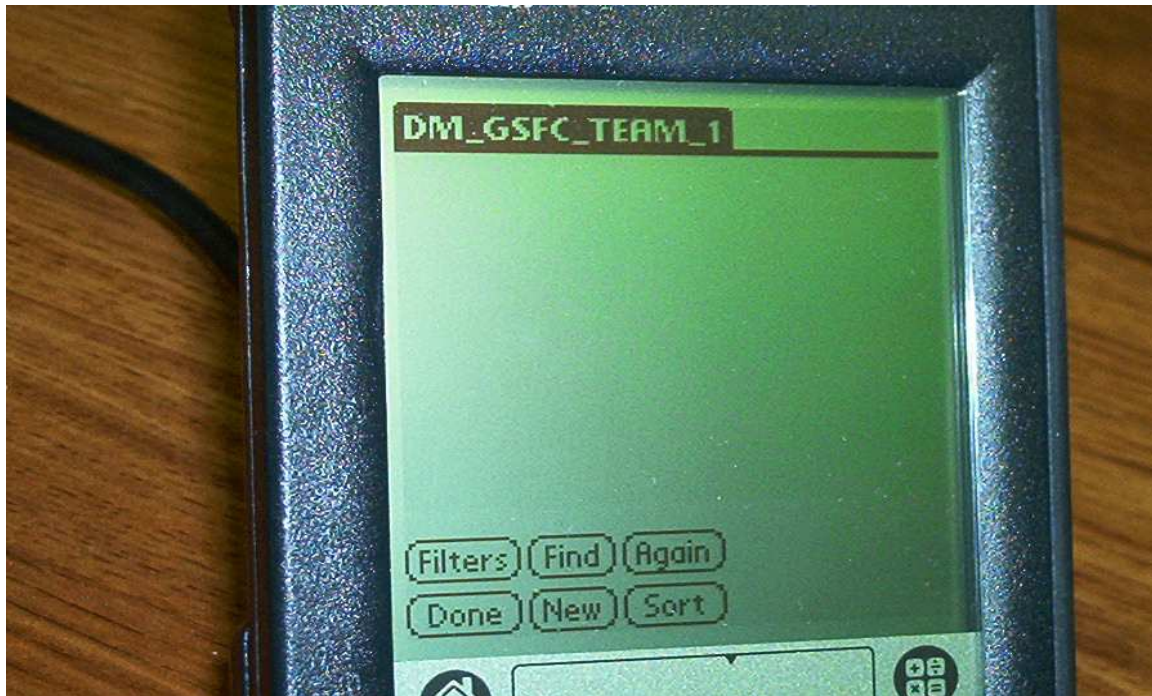
Figure 30: Highlight and choose team

11. Choose Team
